**To:** Sonny Thornborrow, US Forest Service

**From:** Randal English

**Date:** May 28, 2020

**Subject:** Yearly Operations Summary – 2019 Beal Year 12 RO Treatment Season

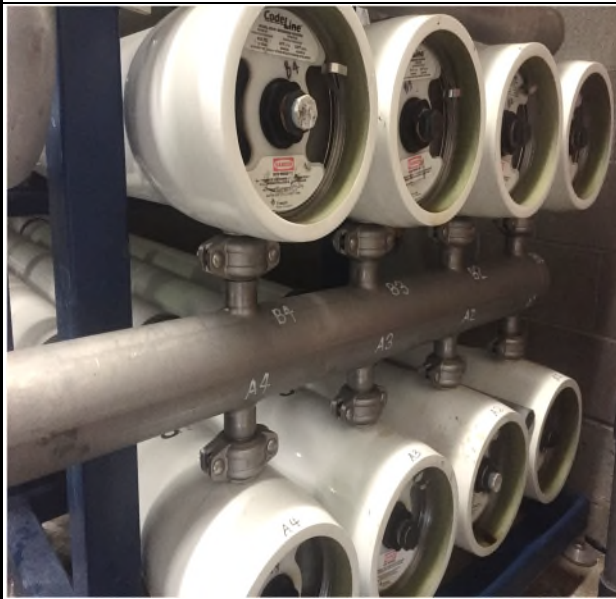
Prior to the start of the RO unit, several of the first pass membrane elements (first element of each vessel; 4 vessels per array; A, B, and C arrays in 1<sup>st</sup> pass) required cleaning due to observed debris lodged in the feed ends of the elements. The debris included small particulates of precipitated scale, sand-like particles, and other organic debris which had been observed during removal of the elements in the prior year. Membranes of the "B" and "C" arrays were installed just as they had been in 2018. The four (4) elements located at the feed side of the "A" array were reversed and placed in the back end of the vessels so that any debris dislodged would be removed with the waste stream during normal operations. The A and B arrays were then mechanically isolated by replacing the feed manifold which normally distributes feed waters to both arrays simultaneously (see Photo 1 below) with a single feed manifold (see Photo 2 below) and each array was then flushed with the CIP unit so that any debris dislodged would be captured by the CIP filter system.

Photo 1. RO A & B Arrays manifold feeding both arrays simultaneously.

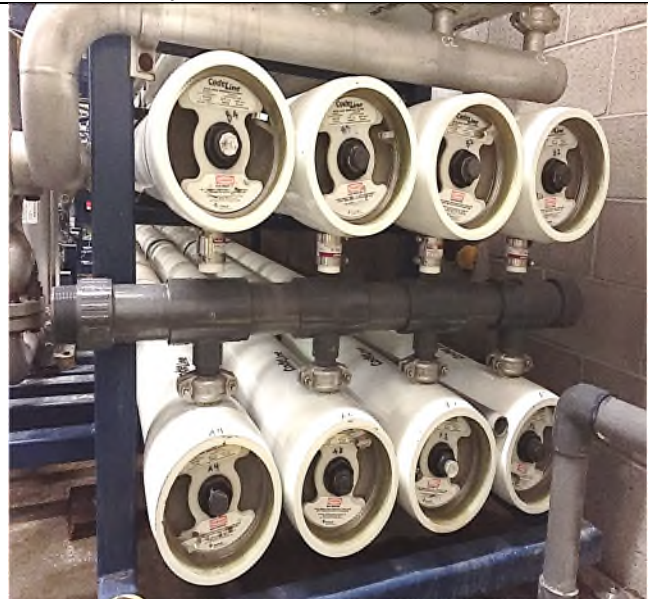
Photo 2. Single manifold placed to feed A or B array independently during cleaning operations.

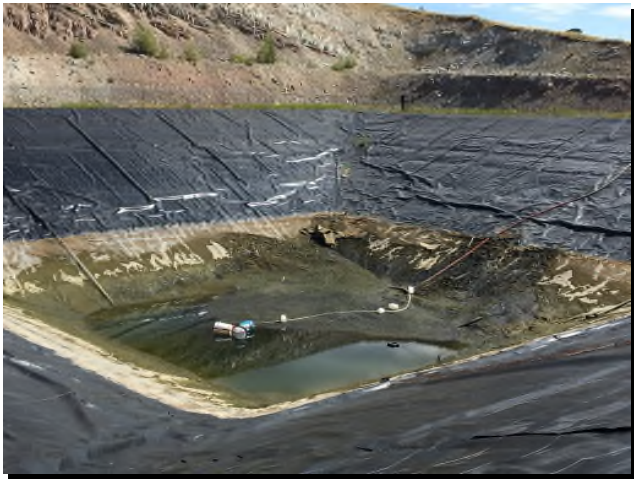
- Miscellaneous debris was observed at or near the bottom of the pond which included pipe, pipe fittings, and geotextile fabric.
- Sediment present was highly liquified with low cohesive strength.

Photo 3. Tear in Freshwater Pond liner spring of 2018.	Photo 4. Freshwater Pond – September 2019.

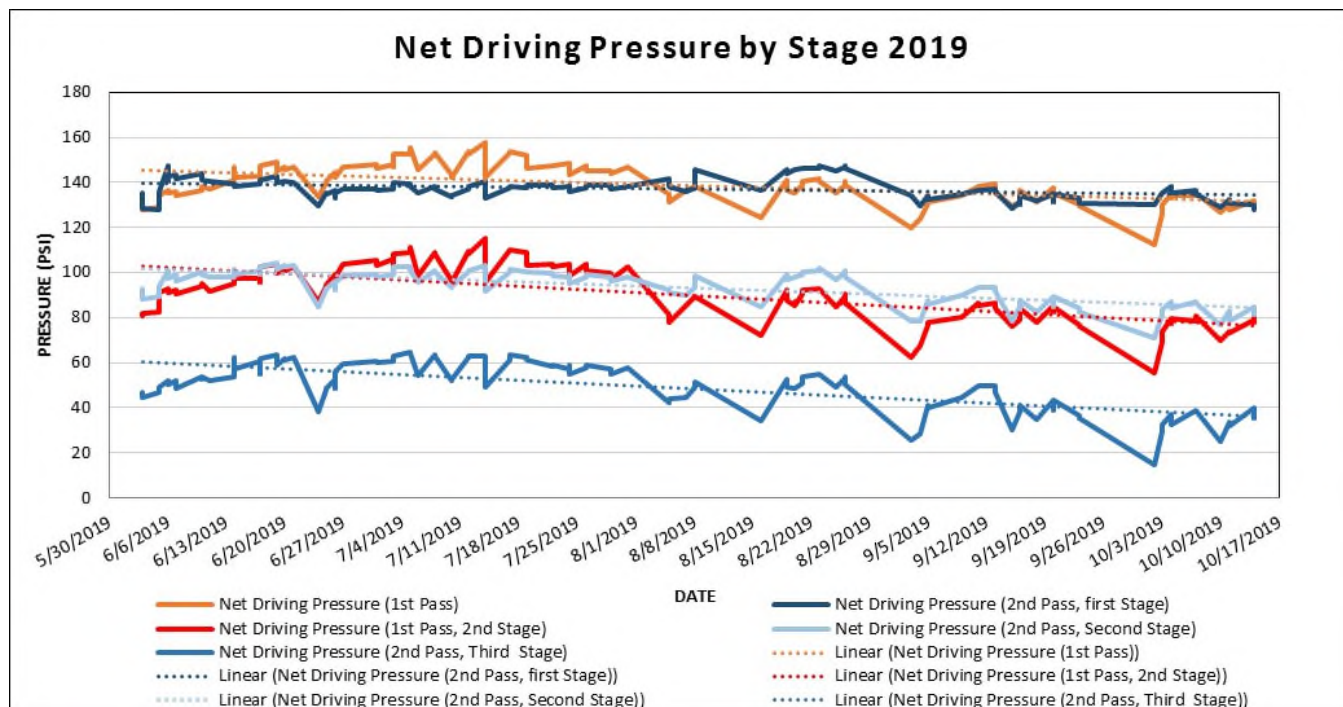
**Figure 7. Average Net Driving Pressure by Pass and Stage**

As stated above, evaluation of this type of data is complicated due to the everchanging feed water chemistry which results in continual system adjustments in order to maintain the appropriate flows and pressures. For most RO systems, feed water chemistry is generally consistent, so frequent system adjustments are not required which results in a much smoother graph.

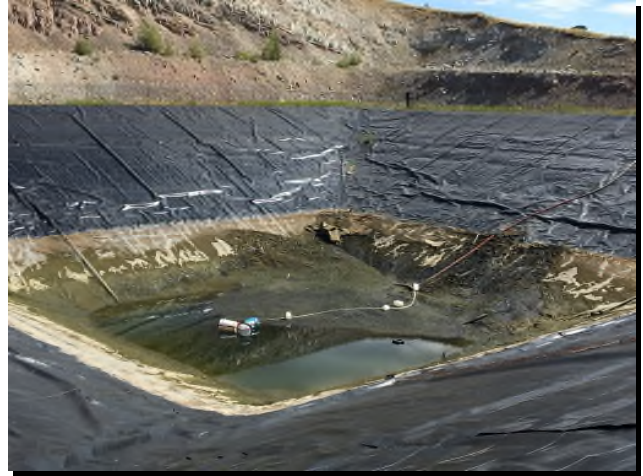
Photo 4. Freshwater Pond – September 2019.

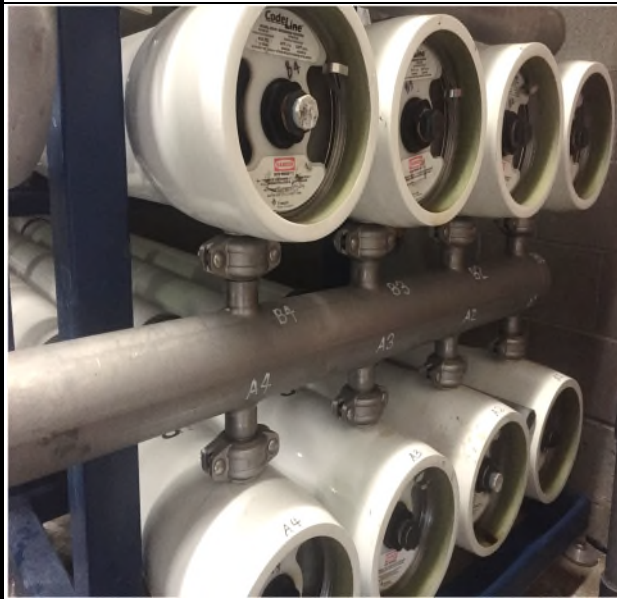
Photo 1. RO A & B Arrays manifold feeding both arrays simultaneously.

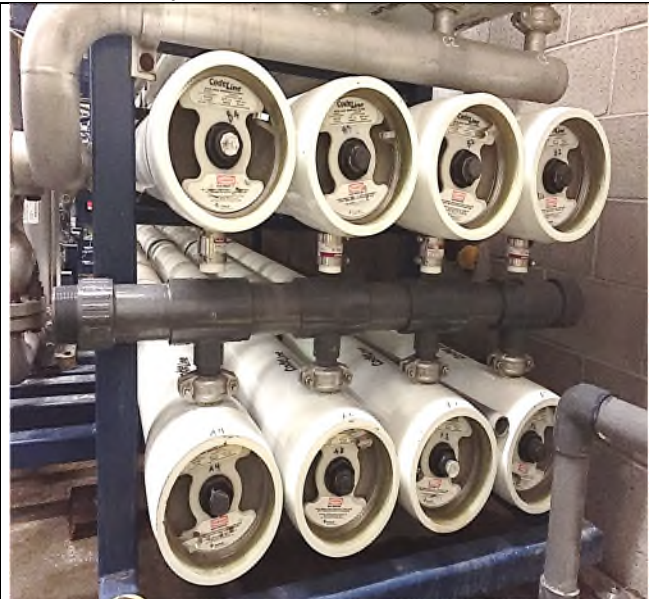
Photo 2. Single manifold placed to feed A or B array independently during cleaning operations.

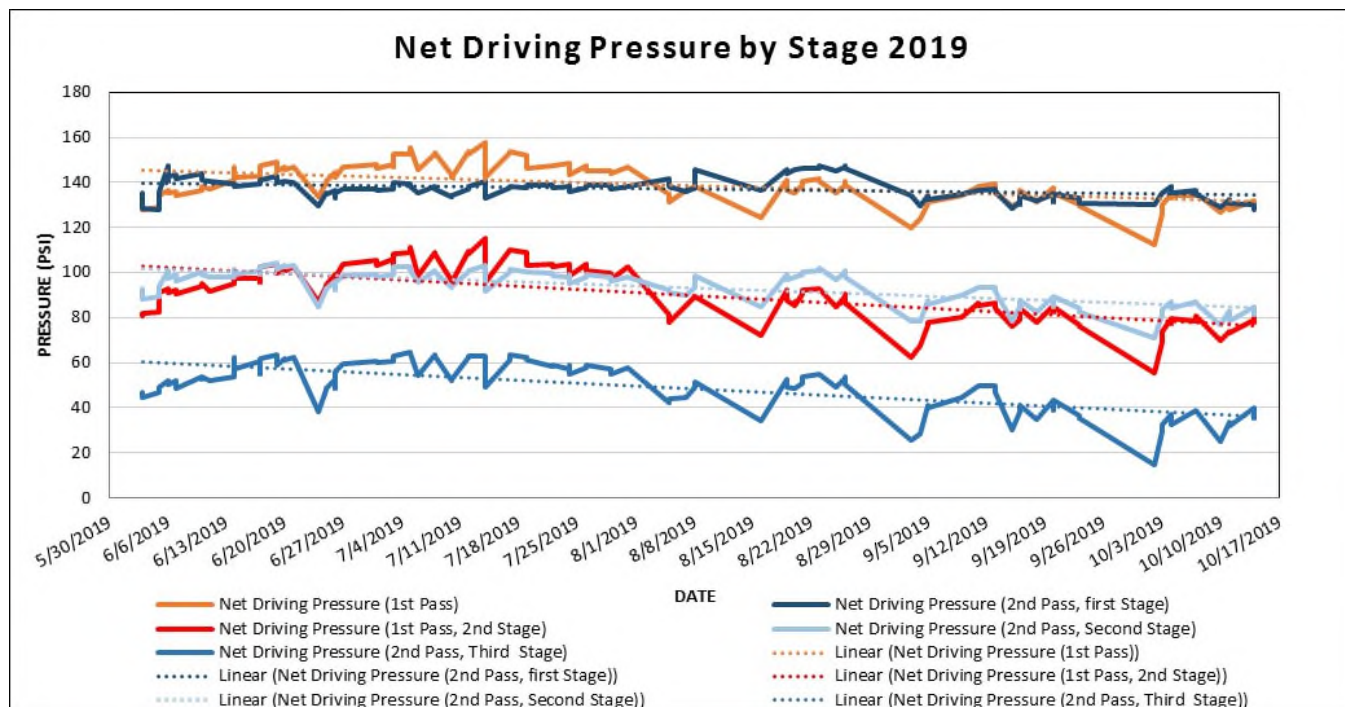
**Figure 7. Average Net Driving Pressure by Pass and Stage**

As stated above, evaluation of this type of data is complicated due to the everchanging feed water chemistry which results in continual system adjustments in order to maintain the appropriate flows and pressures. For most RO systems, feed water chemistry is generally consistent, so frequent system adjustments are not required which results in a much smoother graph.

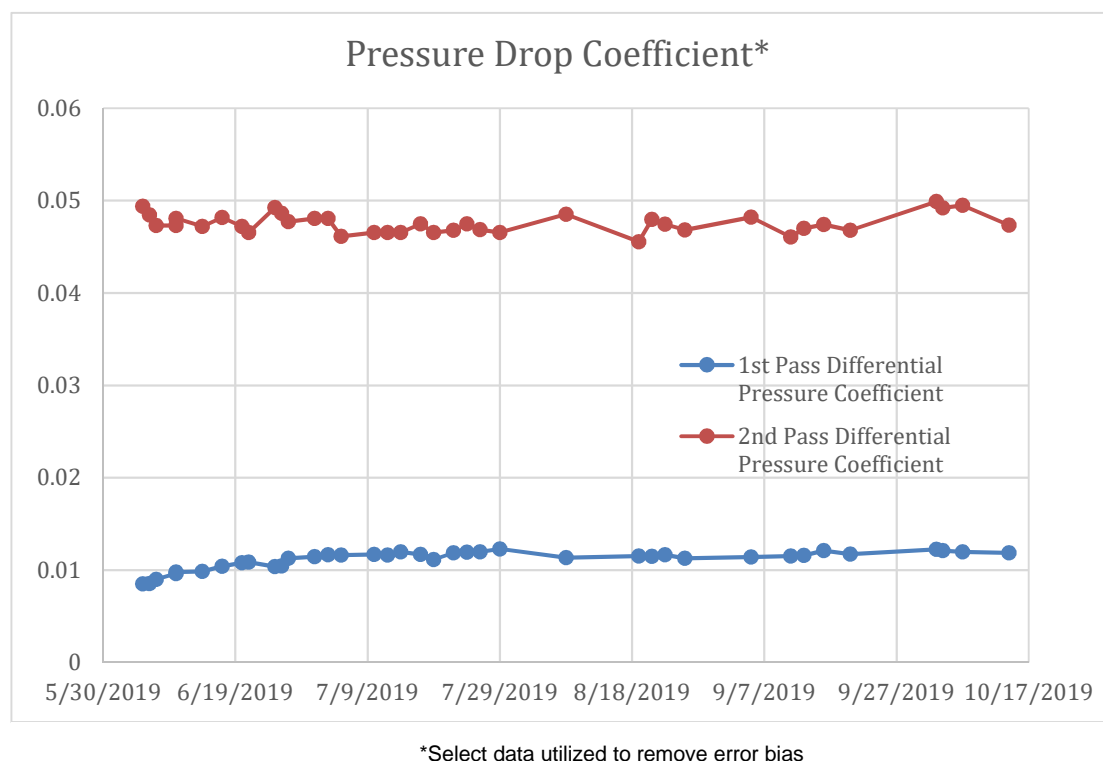
**Figure 9. Calculated Pressure Drop Coefficient**

In general, increases in the differential pressure drop coefficient are often used as an indicator of obstruction to flow (fouling) within the system. Foulant may be associated with particulates, biological growth, or dissolved solids precipitation (scale). Fluctuations in the coefficient can also be attributed to system adjustments, meter calibrations, feed and concentrate valve functionality, and system stabilization following shutdowns / restarts.

Increases in the 1<sup>st</sup> pass differential pressure drop coefficient during the first month of operations supports possible membrane fouling followed by more stable performance; however, there were also significant system adjustments that occurred during the first few weeks of operation. The variability of 2<sup>nd</sup> pass coefficient values are likely due to operator adjustments to balance the system which resulted in fluctuations of the 2<sup>nd</sup> pass feed concentrations due to varying amounts of raw water passing through valve YV125A, instrument calibrations (flow meters and transducers), and issues associated with the deteriorating condition of the 2<sup>nd</sup> pass feed valve.
